Case Study

Oldonyiro, Kenya

ARlavCAD analysis enables correct installation of properly-sized and located air valves, ensuring smooth flow of water from source to destination

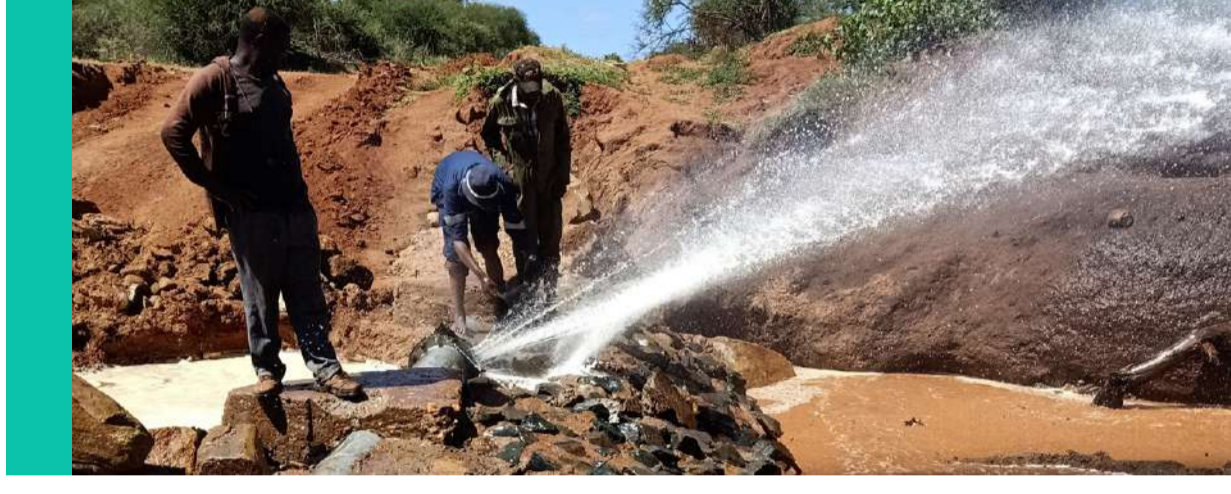
Challenges Constant pipe bursts during pumping tests

During test pumping, the pipeline experienced various bursts. The water was never successfully pumped above 10 bars of pressure, the level required to pump it to the reservoir tank. No air valve sizing and location analysis had ever been conducted, and the pipeline did not have drainage valves installed, making it impossible to drain the pipe to remove debris during test pumping.

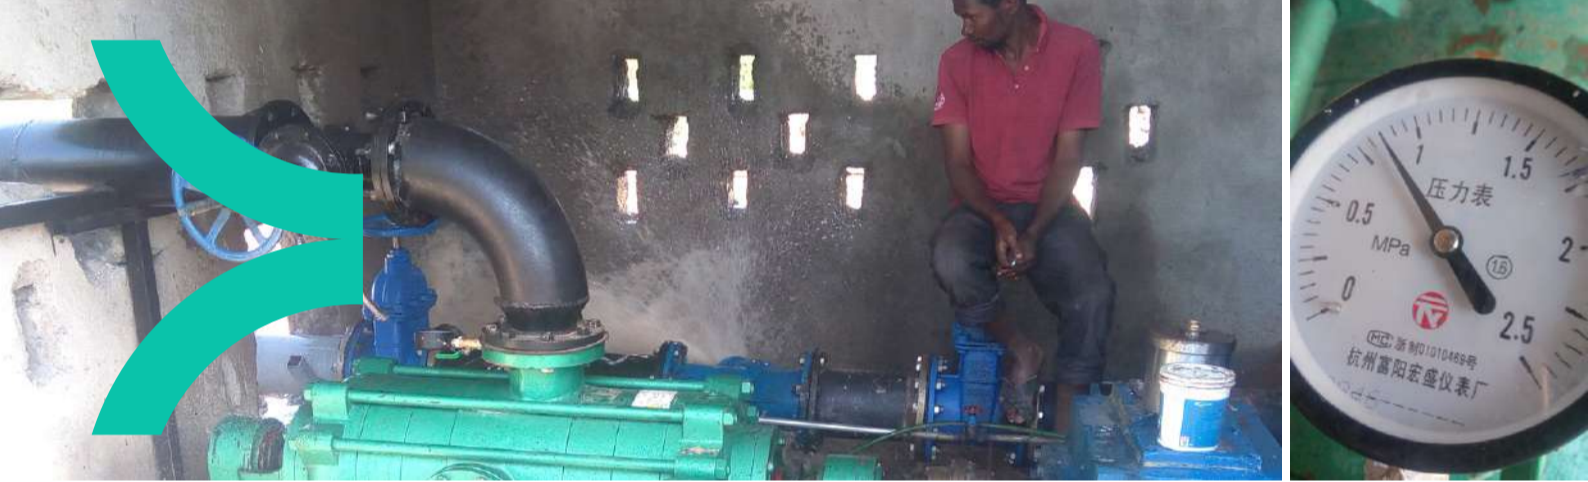
Solution Air valve sizing and location analysis

Air valve sizing and location analysis was carried out using ARlavCAD sizing and location software. Following this analysis, D-46 air valves, properly sized and with the required air flow capacity, were installed along the pipeline to minimize pressure transients, control air, and optimize flow. Air vent pipes were installed on the air valve chambers, and washouts were installed at all the low points, to enable flushing of debris from the pipeline.

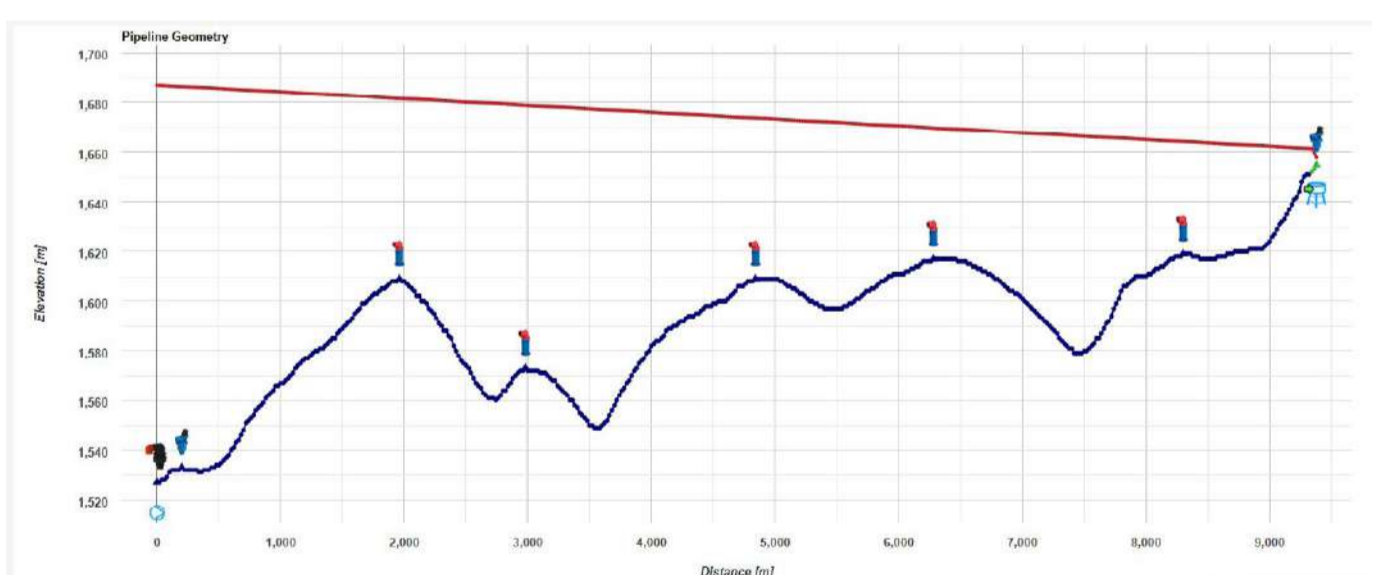
ARlavCAD Sizing and location report

Data collected from the field was input into the ARlavCAD and analysis was carried out. The ARlavCAD graphical representation below shows the locations and types of air valves required.

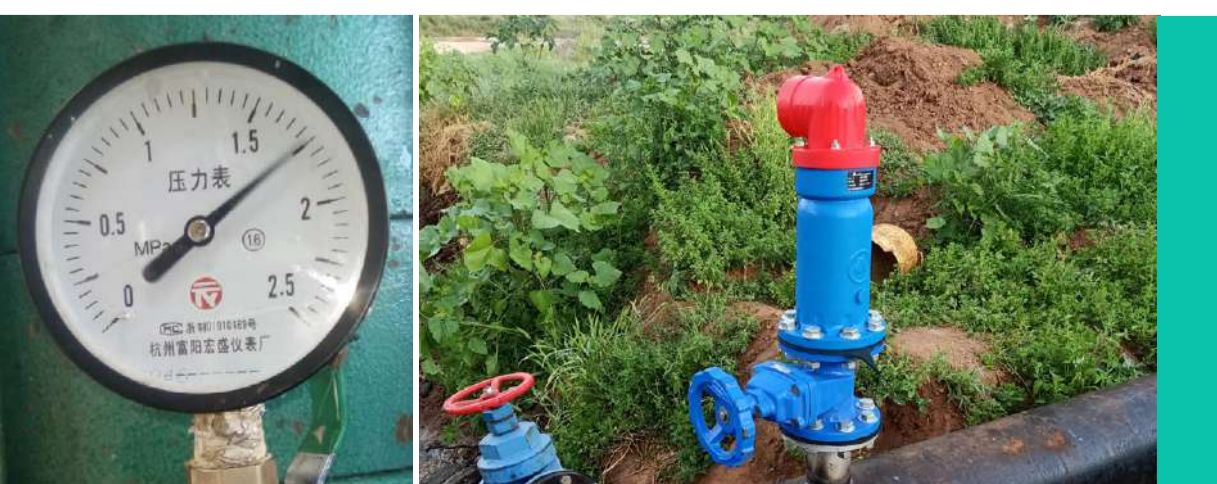
Following installation of the new A.R.I. D-46 air valves in accordance with the ARlavCAD analysis, the air locks and accumulated debris that had prevented water flow were eliminated, and the upsurges and down surges that had been causing pipe bursts were mitigated. As a result, water is now successfully pumped to the reservoir tank.
