Wessex Water Case Study

Aquestia's predictive smart water air valve, **ARISENSE**, detects issues before they occur.

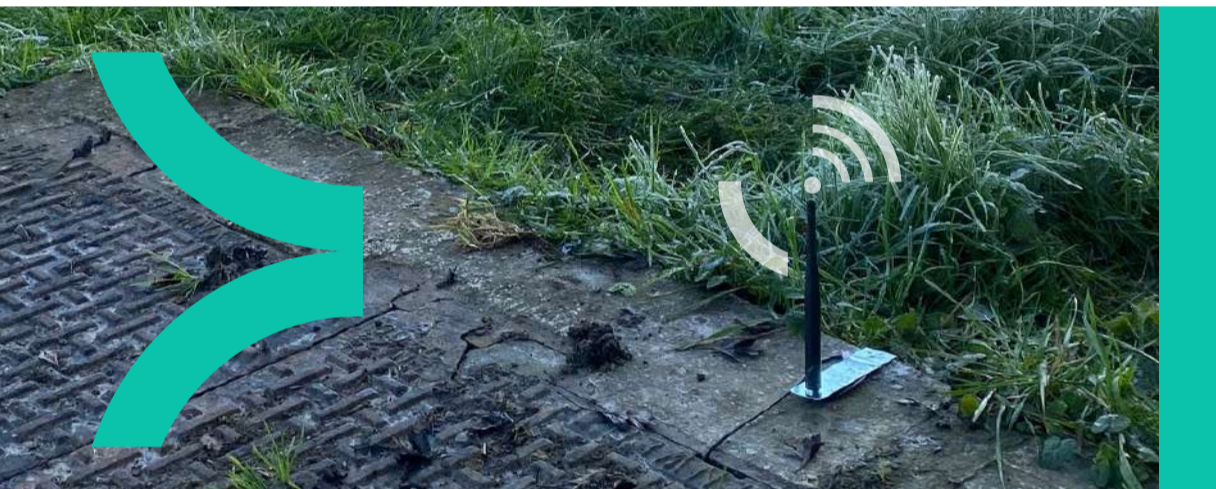
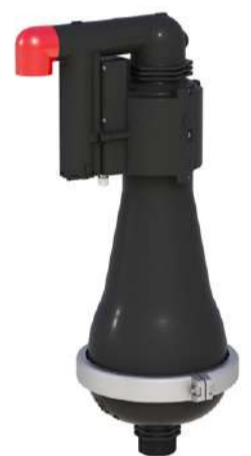
The **ARISENSE** smart air valve was installed with a manhole pit-level float switch sensor, enabling Wessex Water to know in real time if the manhole chamber of the air valve becomes flooded.

To overcome the communication issues of remote locations, an external antenna was discretely installed above the manhole cover, at a height of 5 cm.

The **D-025LNS-AS** DN80 (3") **ARISENSE** was specially specified with a non-slam feature to prevent surge in the event of rapid filling of the system, enabling the valve to operate under a wide range of system conditions.

Given the sensitive location of the **ARISENSE** smart air valve, a special low-pressure float and seals were specified, to ensure that the valve seals at 5 cm water column volume.

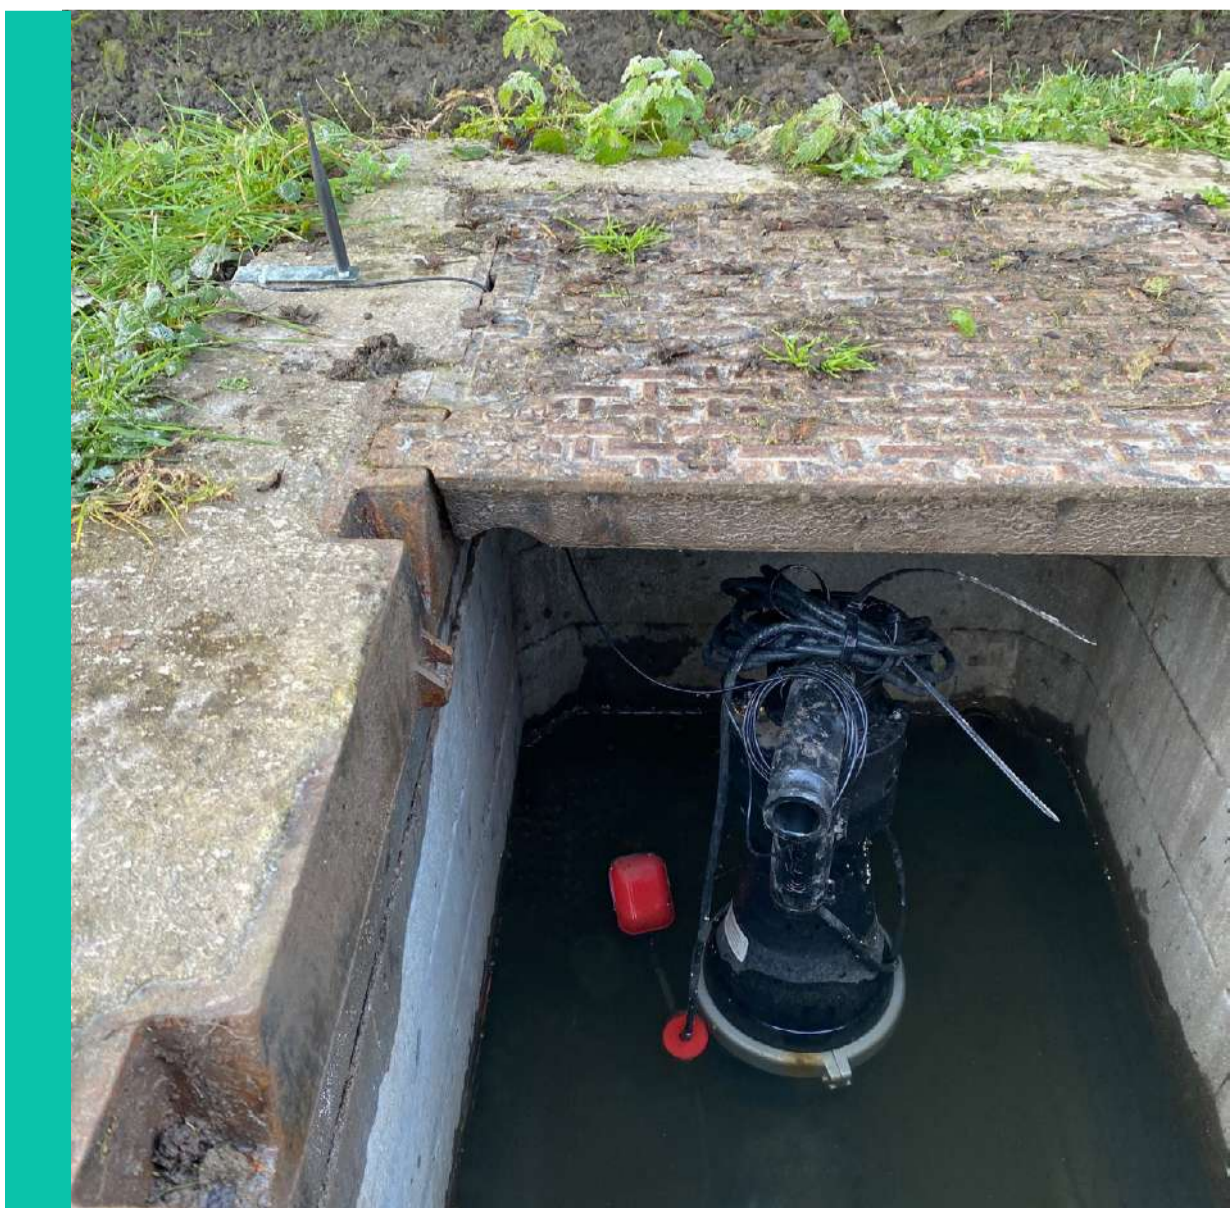
A member of the Wessex Water wastewater air valve maintenance team was dispatched to the site, where it was discovered that the chamber had flooded due to water ingress through a duct. This had been exacerbated by high ground water levels. As a result of the alert, the duct was sealed, preventing any further issues.

The installation was regularly checked over a period of two months. At 6.20 am on the morning of 14th December, Wessex Water received an alert via SMS and email from the air valve, indicating that there was water in the chamber.
