Case Study

Yorkshire, UK

Aquestia's predictive smart water air valve prevents pollution incident.

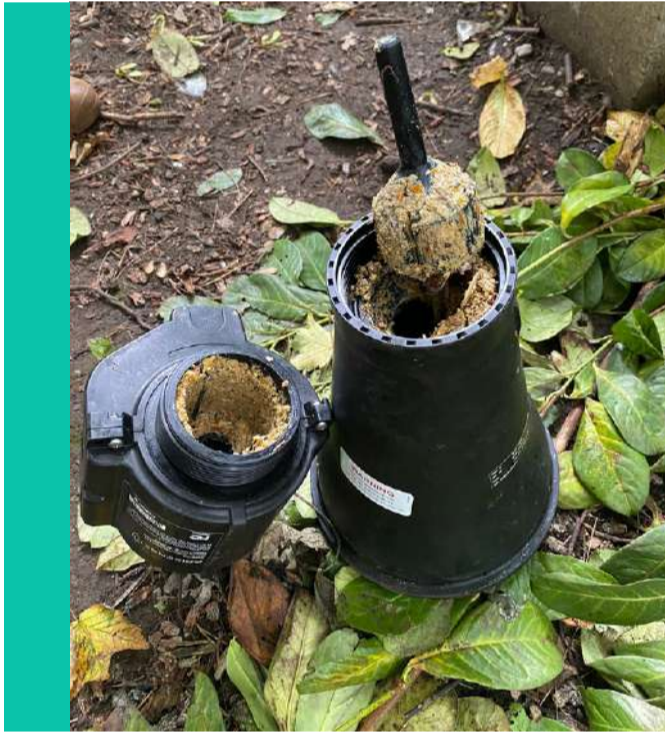
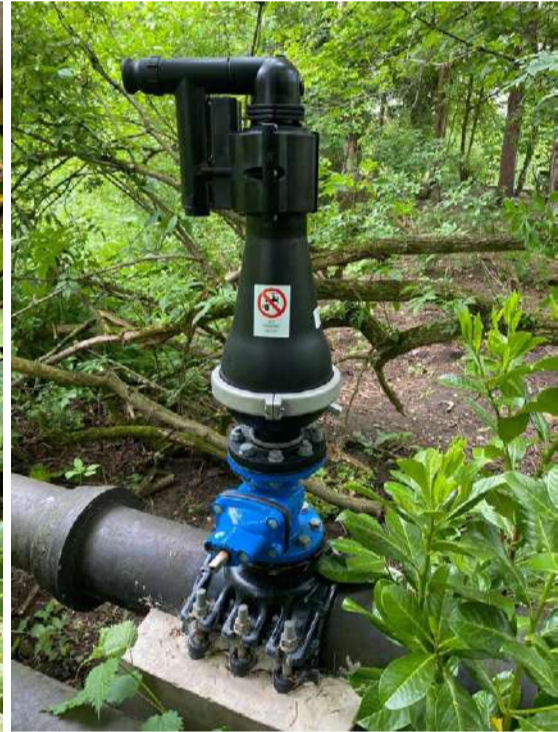
Yorkshire Water, accompanied and advised by Aquestia's UK partners, AVK-UK, decided to install an Aquestia ARISENSE smart air valve at the site of the riverbank to generate early alerts of potential sewage leaks so that they could be avoided.

The ARISENSE includes internal sensors to track air valve performance and issue alerts of any internal events, and external sensors for monitoring the network, such as a pressure sensor that indicates pressure along the pipeline. This provides feedback on various key operational parameters, including overflow, leakage, blockage, pressure, tampering, and tilt/shock. If any of the sensors, internal or external, is activated, email and text messages are sent to all subscribed users.

ARISENSE has already proven its value. In one particular incident, the ARISENSE smart air valve overflow alarm alerted Yorkshire Water to a risk, and they were able to clear the blockage by cleaning the valve internals, quickly returning the sewerage pipe to full capacity.
